# **Heritage Impact Assessment: remains of homestead on Krantz Fontein 258, Kokstad**

**Prepared for: Icando – June Lombard & Associates  
P O Box 115  
Link Hills  
3652  
November 2013**

## **Heritage Impact Assessment: remains of homestead on Krantz Fontein 258, Kokstad**

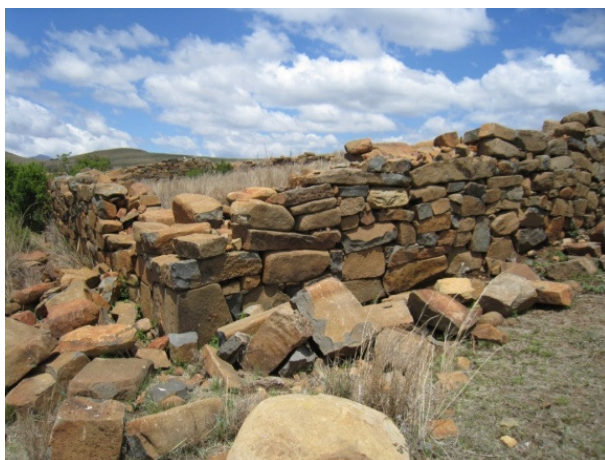
The most prominent of the remaining structures is an old stock kraal some distance up the slope of the hill from the main complex. It is a substantial rectangular structure, roughly 23m by 33m, and constructed of packed fieldstone to create a wall about 1m wide (see Figure 7). To the east is an entrance. The condition of the structure is good, given its drystone nature.

***Fig 6: Kraal from the north corner***

*The old stock kraal is a good example of a vernacular stock structure of which there are many extant examples. It is considered by the author as being low in heritage value, from an architectural, historical, scientific, technical and social aspect.*

*Furthermore, in the opinion of the author, demolition, would it be sought, could be carried out.*

- it is recommended that the main stock kraal be dismantled and that the stone be redeployed in a structure or structures that support the landfill from an administrative point of view***
- it is recommended that areas of the old garden be retained as a sheltered spot in the construction of any ancillary buildings in the development of the new landfill site***

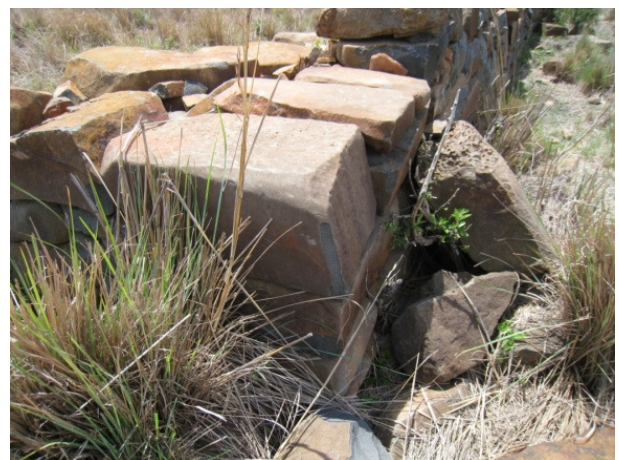
***Fig 7: Corner detail***

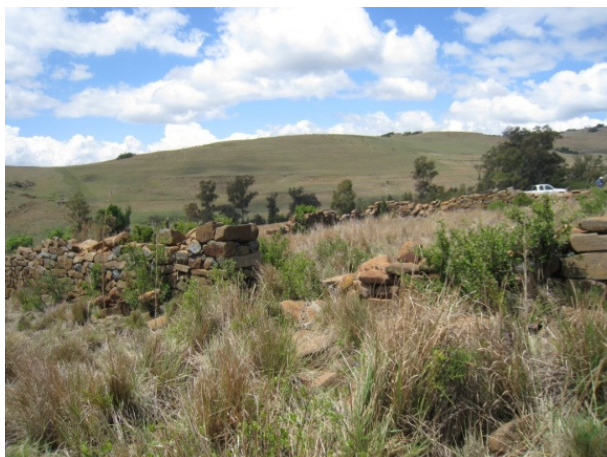
**Fig 8: South corner**

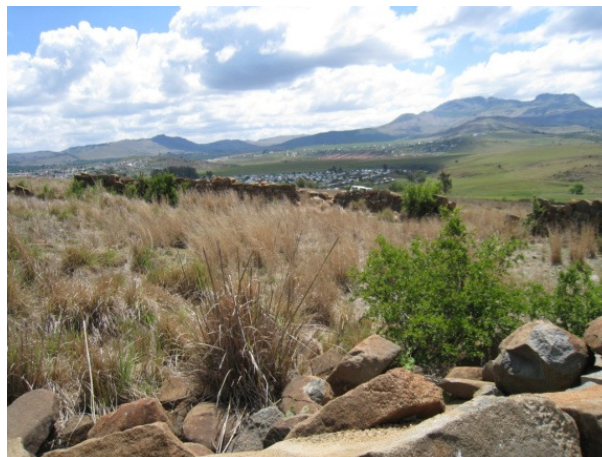
**Fig 9: View south corner east to entrance**

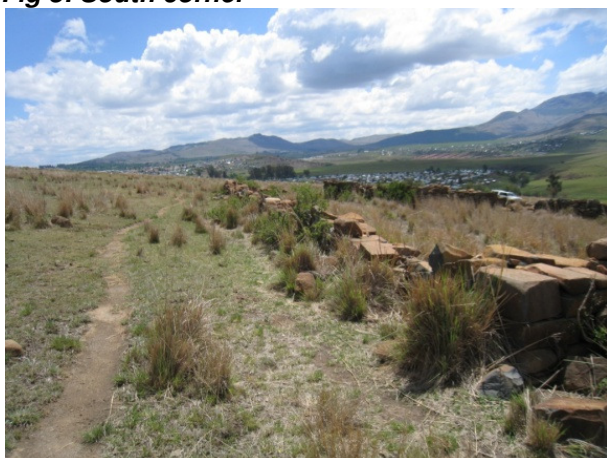
**Fig 10: Kraal with Bhongweni in the background**

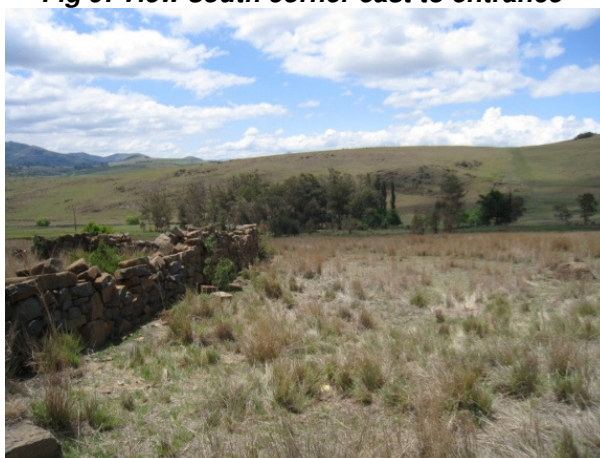
**Fig 11: View down to main homestead**

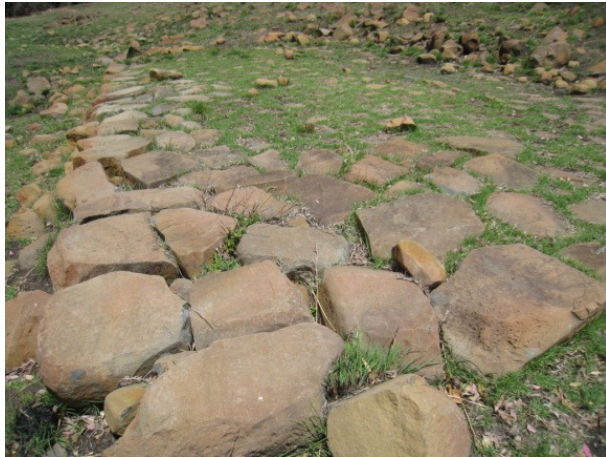
The remnants of the largest structure on site measure approximately 14m x 48m. It has, in places, evidence of reasonably careful flagstones, but the spread of the stone floor is not consistent across the site, suggesting that it comprised a variety of different incremental spaces, added on as needed. The aerial photograph from 1955 does not elucidate as to its material structure.

**Fig 12: Floor structure of main house from north**

***The elevational details of the main house are lost to history. The remnants are a collection of largely undressed stone which is laid to form a stabilised floor.***

***In the opinion of the author, demolition, would it be sought, could be carried out.***

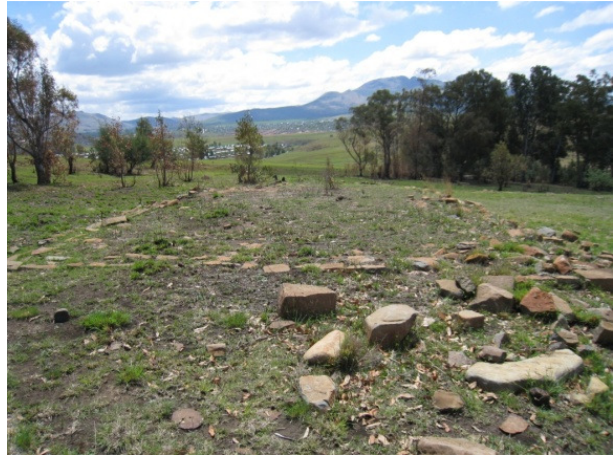
**Fig 13: Demarcation of main house**

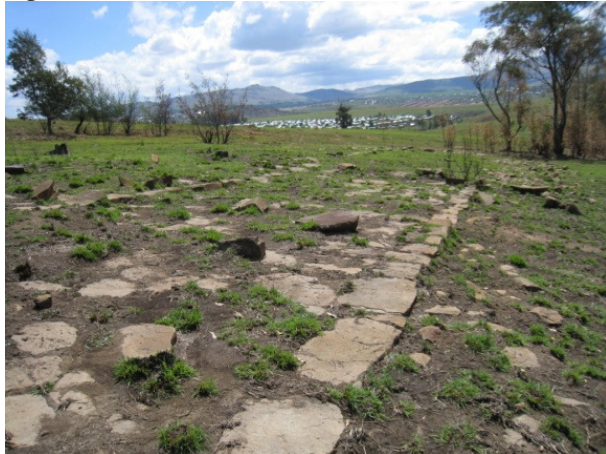
**Fig 14: Floor of main house from the south**

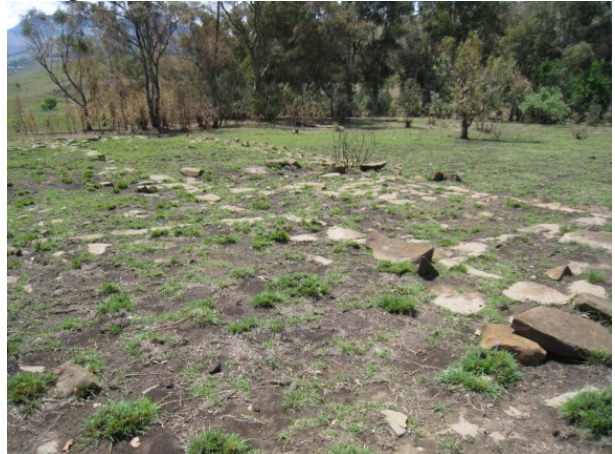
**Fig 15: Floor of main house from the west**

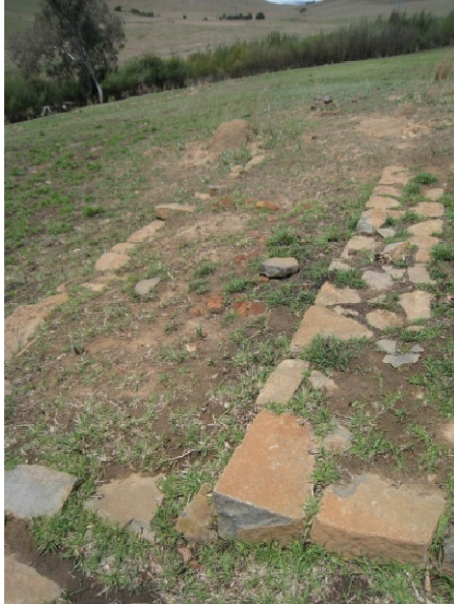
This consists of the foundations of a much smaller building, some 10m x 18m. Like the main house, the main part of the structure has more carefully shaped stone, whilst the addition is founded with a simple outline of fieldstone.

**Fig 16:(left) showing veranda section and main building**

***The elevational details of the house with the veranda are lost to history. The remnants are a collection of largely undressed stone which is laid to form a stabilised floor.***

***In the opinion of the author, demolition, should it be sought, could be carried out.***

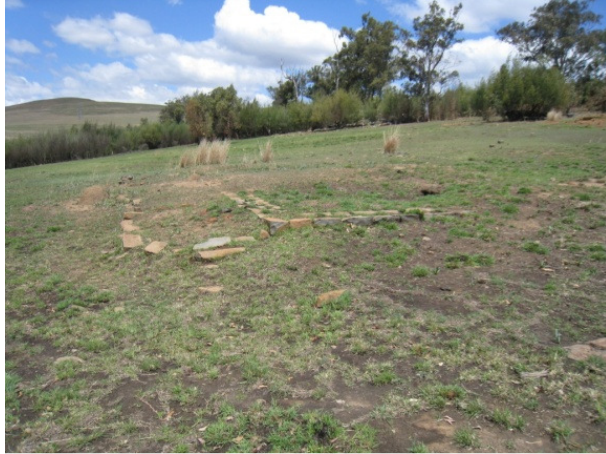
**Fig 17: (above) showing floor from the north east**

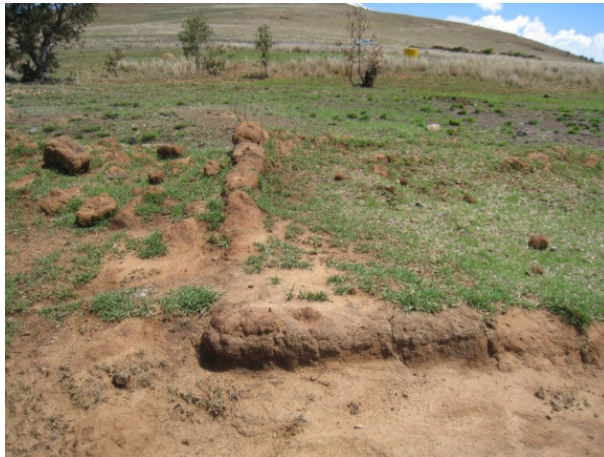
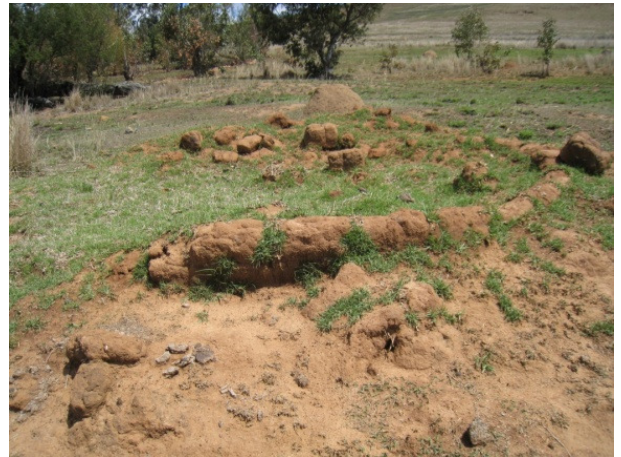
The aerial photograph in Figure 5 shows a couple of small structure, assumed to be staff dwellings. In reality, there is little left of them – in the one instance a shallow depression in the grass reveals the footprint of a small rondawel. In addition, two ruined mud brick structures show the foundations of what was a rondawel, and closely associated with it, a small square building, together occupying a roughly 10m x 11m footprint.

**Fig 18: Showing corner of square mud brick structure** **Fig 19: Showing base of rondawel**

*The elevational details of the staff houses are lost to history, although it can be reasonably safely assumed that they comprised conventional material employed in the construction of rondawels and similar.*

*In the opinion of the author, demolition, should it be sought, could be carried out.*

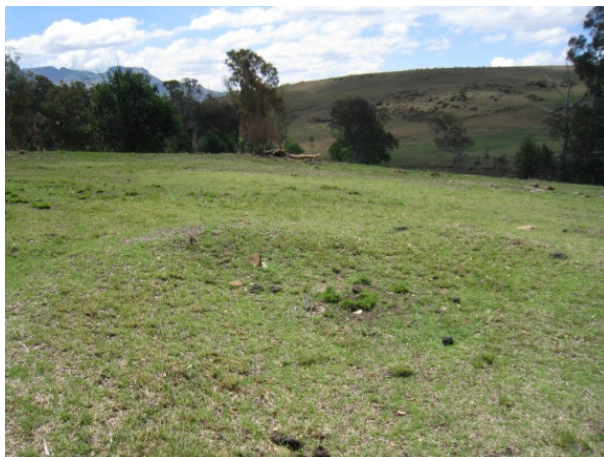
**Fig 20: Depression in position of old rondawel**

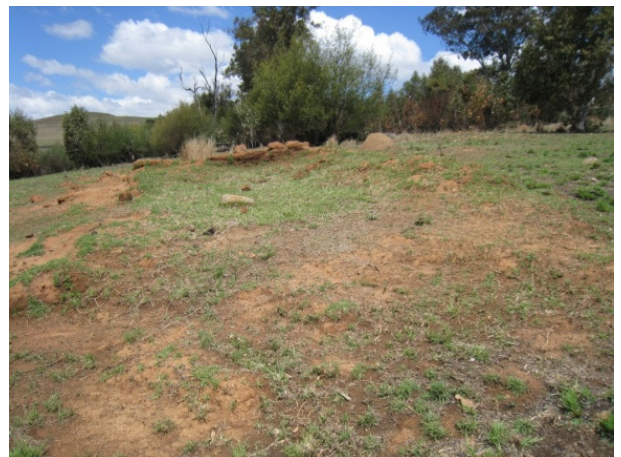
**Fig 21: Mud brick staff house foundations**

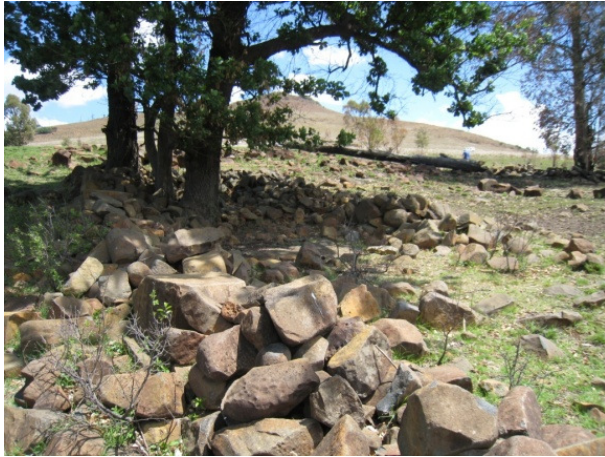
This structure is more randomly planned and built, compared with the structure described in section 3.1. Rather than the fieldstone being systematically packed, it is simply piled on. Furthermore, contrary to the example in 3.1 above, this kraal is neither orthogonal nor circular – it has no distinct planned form. There is also a copse of oak trees growing in the top corner.

**Fig 22: Southern edge towards the oak copse**

***The second kraal has little merit, and is unplanned and random. In the opinion of the author, demolition, should it be sought, could be carried out.***

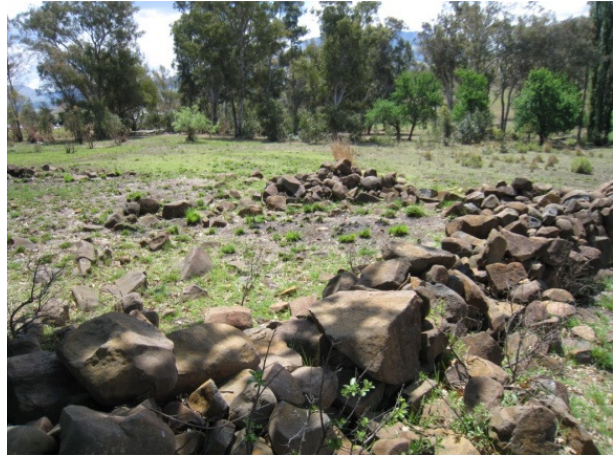
**Fig 23: View of kraal**

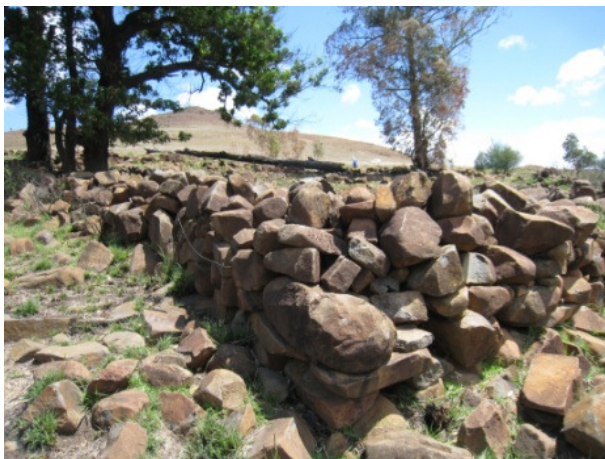
**Fig 24: Lower corner of kraal**

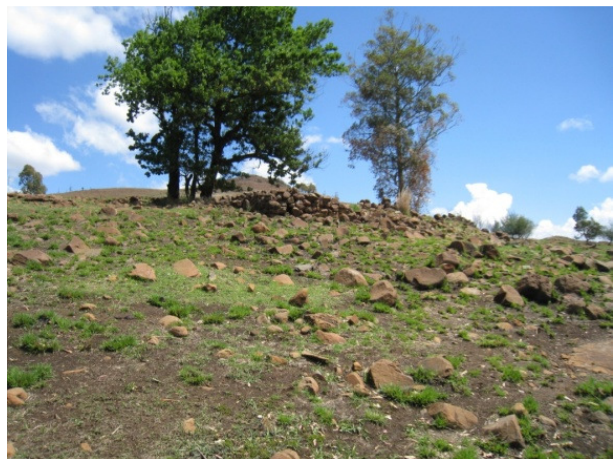
**Fig 25: Kraal from a distance**

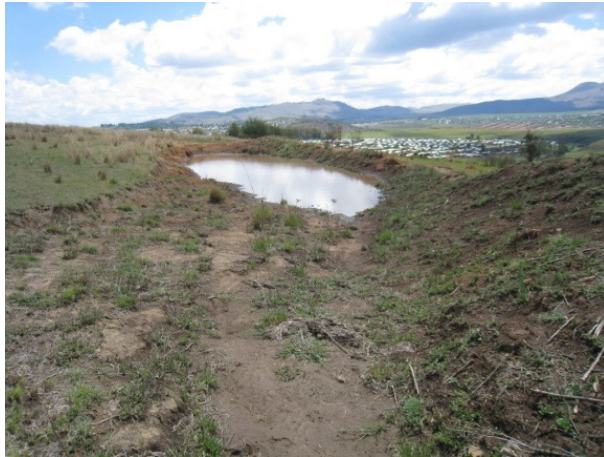
Given its apparent lack of evidence on the 1955 aerial photograph, it is suspected that this rather informal dam is of recent construction. It has a trench leading up to it, running for about 30 metres. The trench has a short dog leg return up the hill to the south.

**Fig 26: Showing the dam from the south**

***It is not certain whether this informal structure could be construed a heritage resource in terms of its age. Despite this, in the opinion of the author, demolition, should it be sought, could be carried out.***

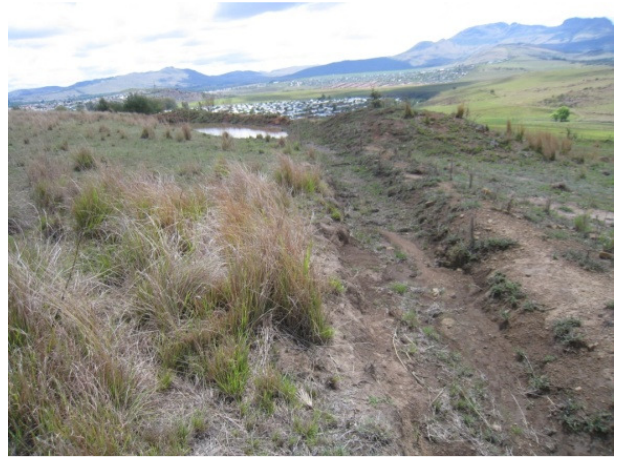
**Fig 27: The feeder trench from the south**

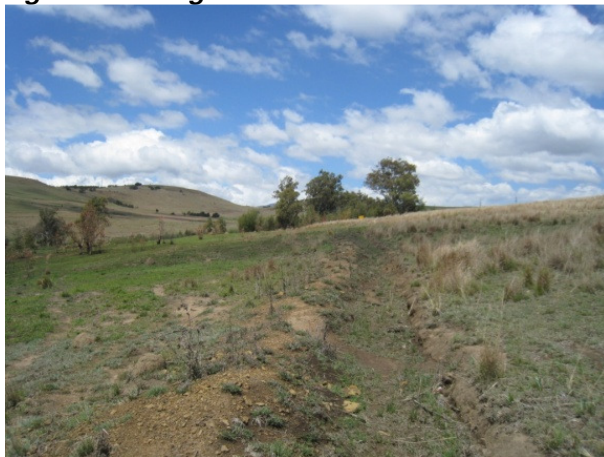
**Fig 28: Trench looking south towards dog - leg**

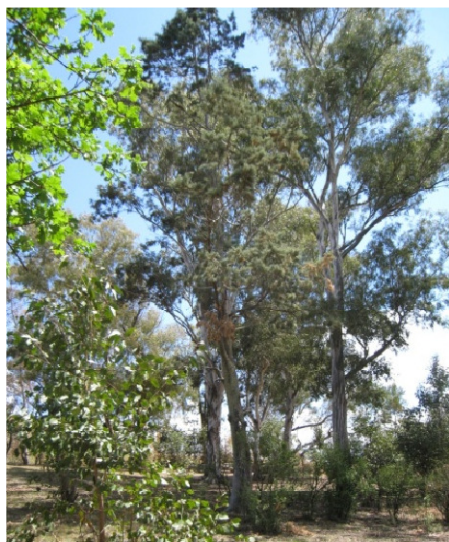
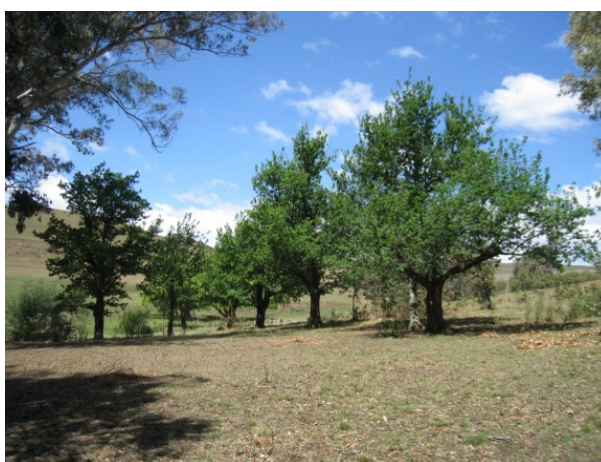
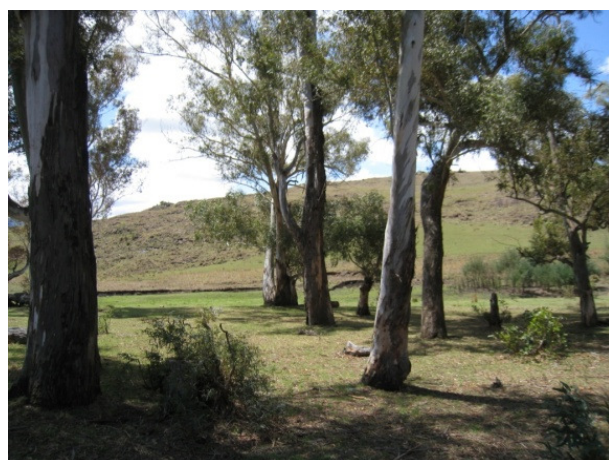
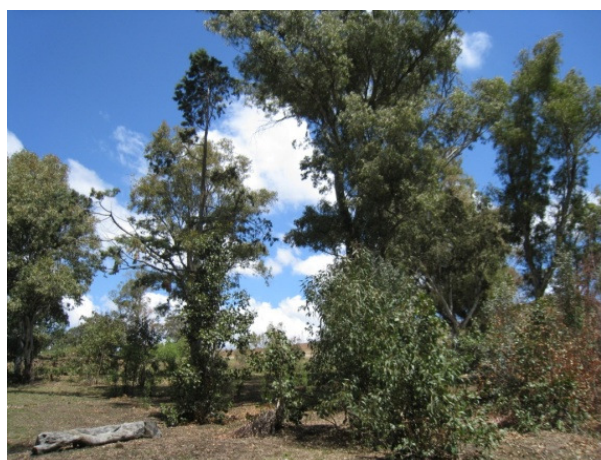
Given the age of the site, and the presence of planted landscape throughout the series of aerial photographs, it is perhaps valid to comment on the human constructed landscape. At the lower end of the site, along the river, are the remains of what used to be a farm garden. Most of the trees are imports: various types of *Eucalyptus* sp. as well as conifers, willows, poplars, oaks and other garden shrubbery. Although any structure of garden has long since disappeared, the retention of all or part of this copse, in a properly managed manner, could be beneficial to the establishment of the landfill in creating a green zone between the landfill and the river, as well as a shaded and protected place in which to establish any ancillary functions of the landfill site.

**Fig 29: (left) Established Eucalypts**  
**Fig 30: (above) Avenue of trees leading down to river.**

**Fig 31: Copse of Eucalypts looking towards creek**      **Fig 31: Old conifers**

***To some degree, the remnants of the old garden, whilst not an outstanding example of heritage, were they properly managed, stand as an opportunity in providing a green zone in the proposed landfill development. It is recommended that these remain and be sutured into the development plan.***
